SENTRY OPERATIONS REPORT FOR THE
2011 JURASSIC OCEAN CRUST MAGNETIC SURVEY

WHOI ABE/Sentry Operations Group

R/V Thomas G. Thompson — November 5, 2011 to December 17, 2011

Publication Date: January 1, 2012

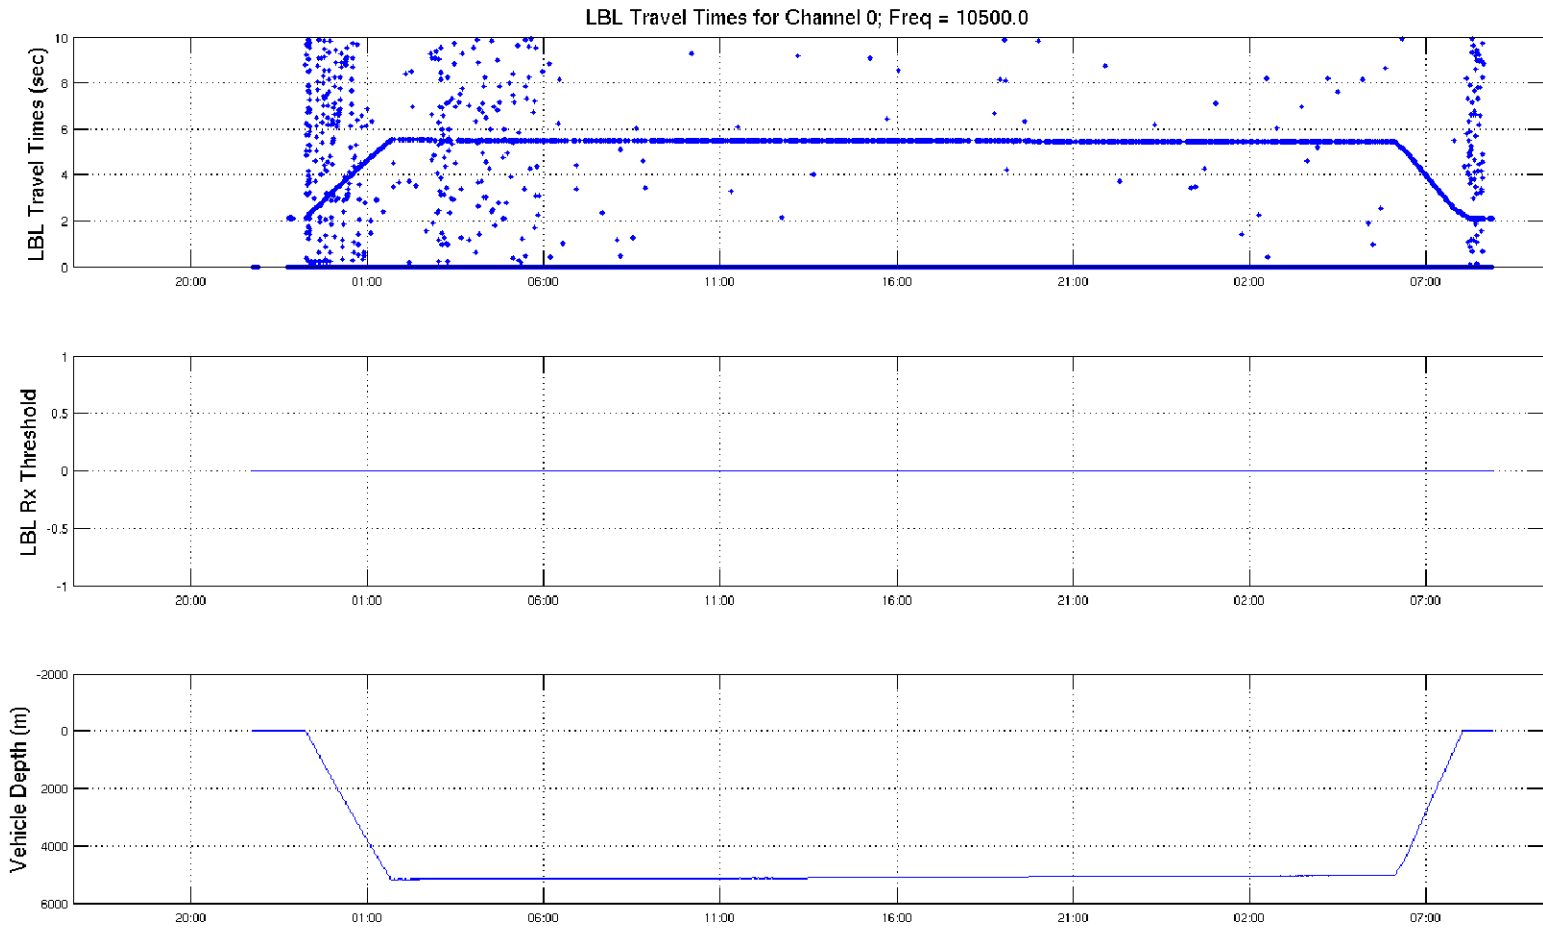
Figure 1: *Top plot:* LBL travel times received by Channel 0 on the *Sentry* LBL transducer for the 10.5kHz frequency during *Sentry* dive 134. During this dive, the ship interrogated at 10.5kHz throughout the dive. This plot shows that the 10.5 pings were reaching *Sentry* . *Middle plot:* Ignore; the gain was set to 18hex throughout the dive. *Bottom plot:* Vehicle depth.

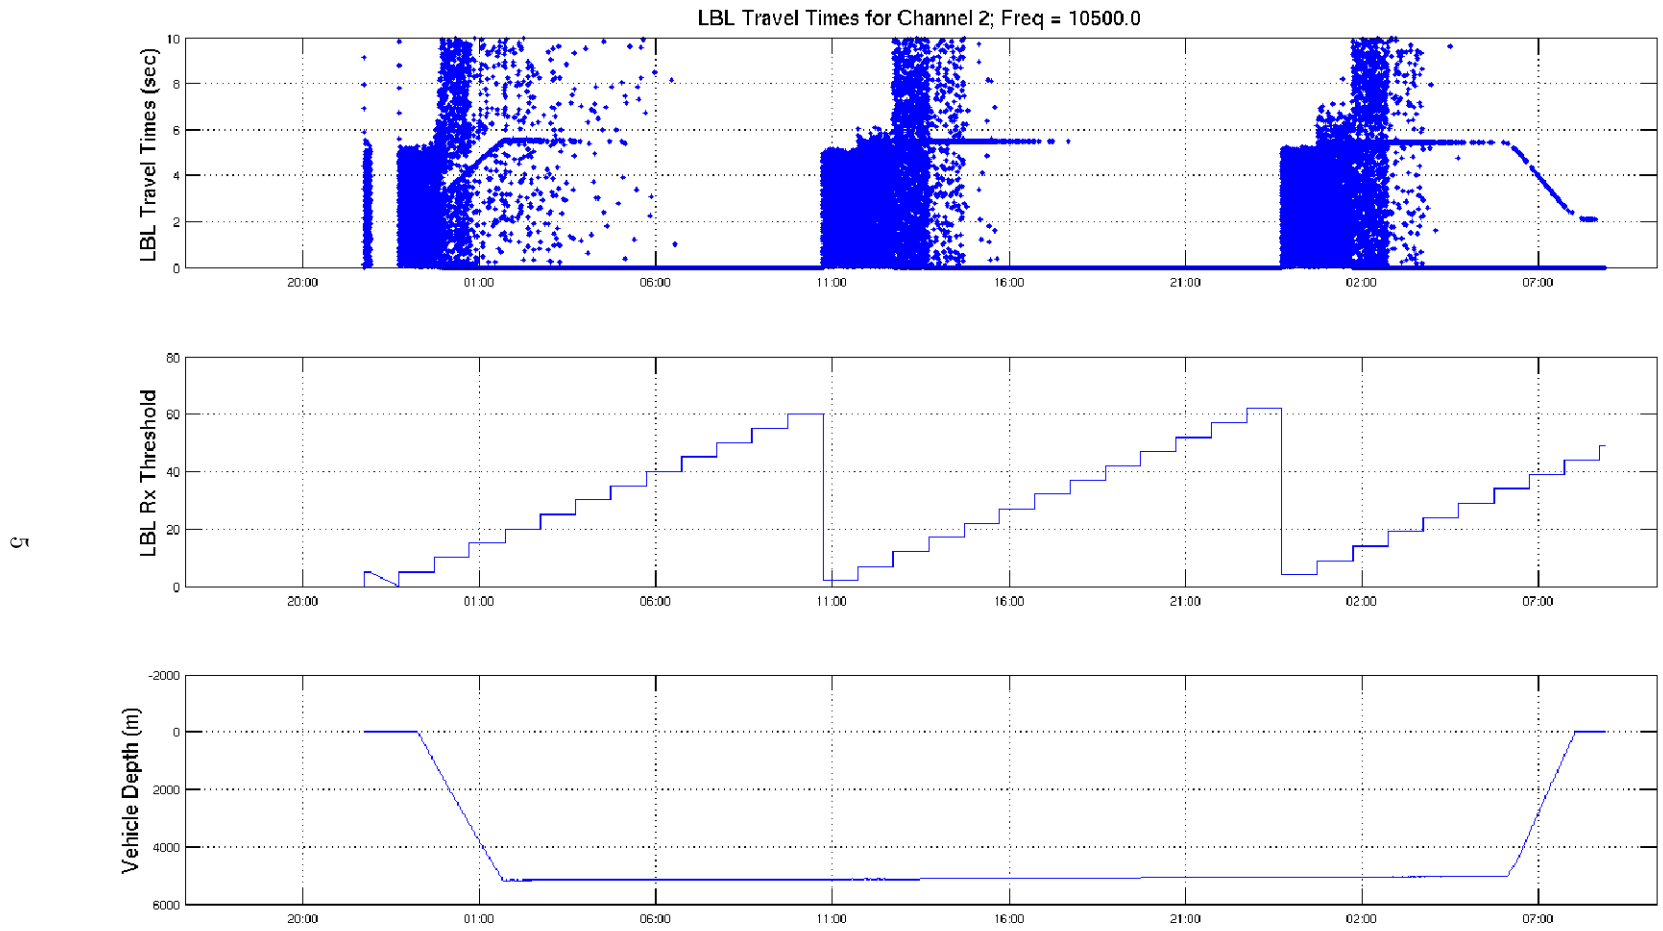
Figure 2: *Top plot:* LBL travel times received by Channel 1 on the *Sentry* LBL transducer for the 10.5kHz frequency during *Sentry* dive 134. During this dive, the ship interrogated at 10.5kHz throughout the dive. This plot shows that the 10.5 pings were reaching *Sentry* when the gain was appropriately set. *Middle plot:* LBL receive gains during the dive. *Bottom plot:* Vehicle depth.

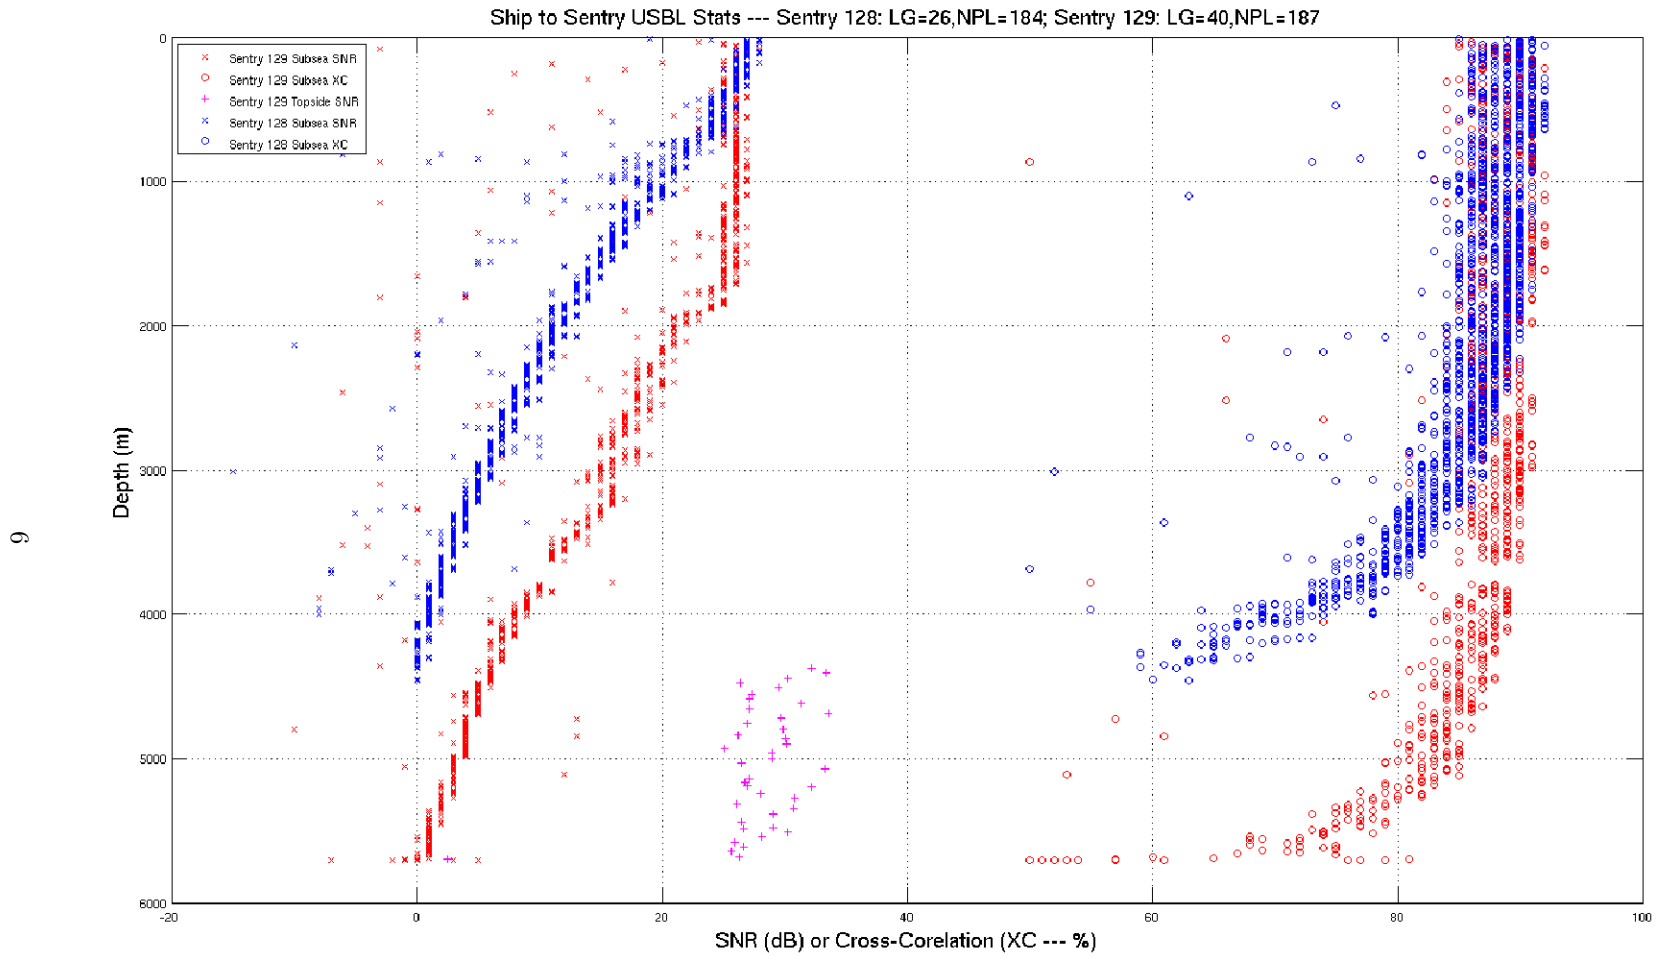
Figure 3: USBL SNR and Cross-Correlation as measured by the Avtrak on *Sentry* on dives 128 (blue) and 129 (red). The LG and NPL setting were increased to their max settings on dive 129. Even at maximum settings, the SNR goes to 0 around 5700m. This is the same depth at which USBL tracking was lost.

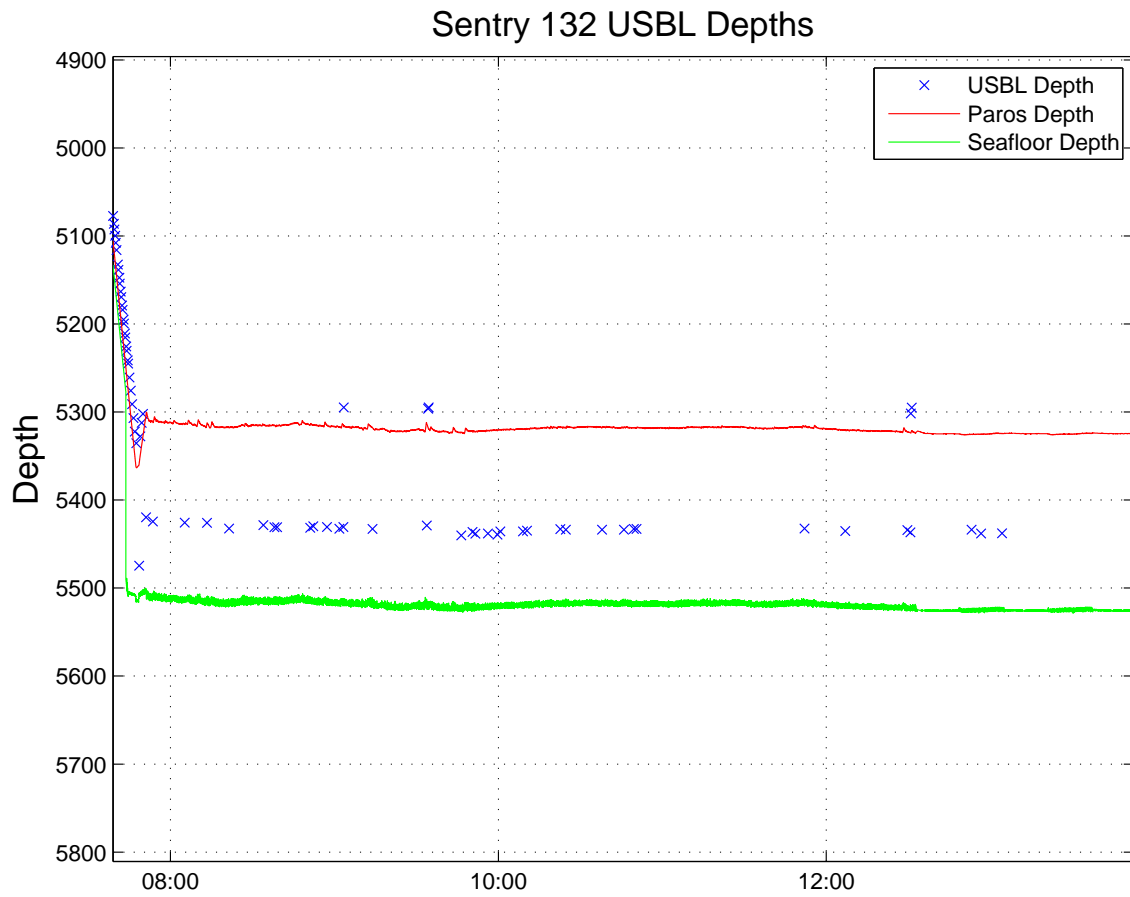
the USBL measured depth could differ from the actual vehicle depth by 100m (Figure 4). This behavior was observed numerous times including on ascent and descent. Simple analysis of “deep” and “shallow” solutions that arrived within 30sec of each other showed that the horizontal positions differed by only 20-40m — sufficient for our operations.

Overall this problem is minor — the “deep” solution is within 2% of the actual vehicle depth. Still this is a systematic error that requires follow up with Sonardyne.

Figure 4: Depths of *Sentry* as measured by the USBL and pressure depth sensor for a portion of dive 134. Many of the USBL fixes differ in depth by approximately 100m. Occasionally, more accurate fixes were available.

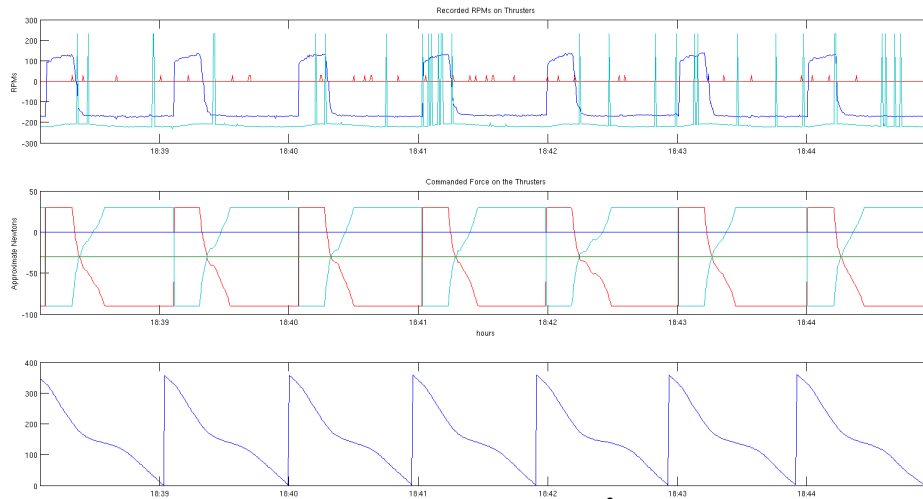
Figure 6: Heading and thruster speeds during Sentry127

be attempting to drive the commanded track line but to repeatedly loose heading control. The second plot (Figure 7) shows the heading of the vehicle as well as the thruster commands and rotations showing the loss of heading control as a result of a non-functional starboard forward thruster.

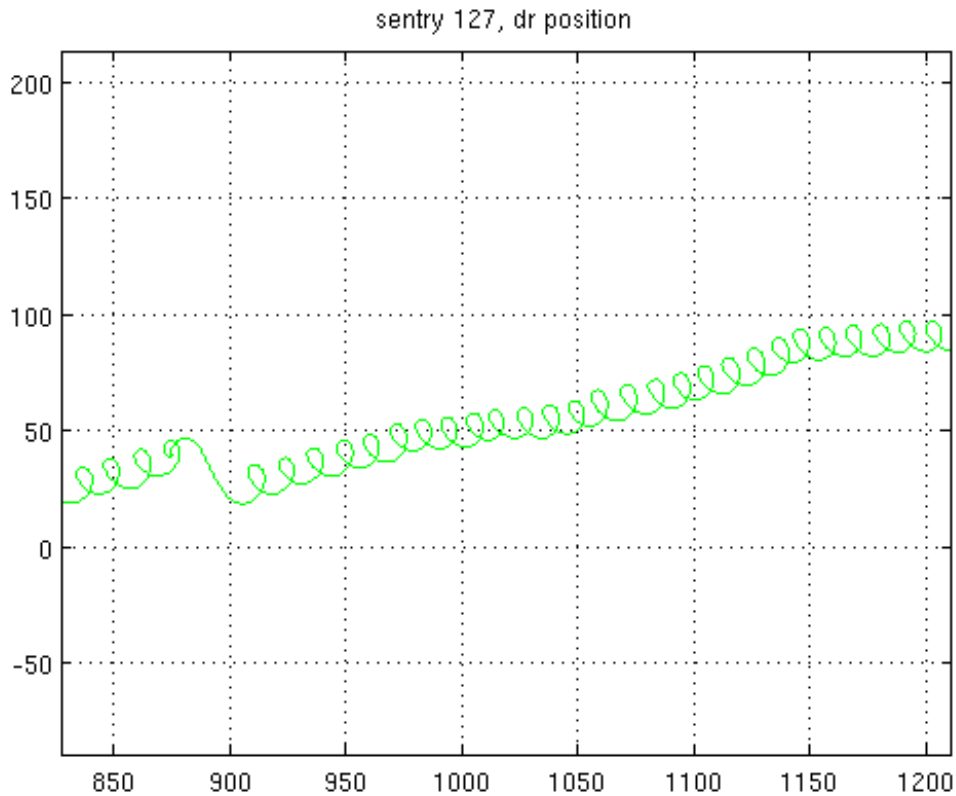
The failure of the thruster caused the vehicle to lose stability at speeds in excess of 0.6m/s. Figure B.1 shows the DVL track of the vehicle during an unstable portion of the dive. The vehicle can be seen to

Figure 7: Portion of the DVL track from dive 127

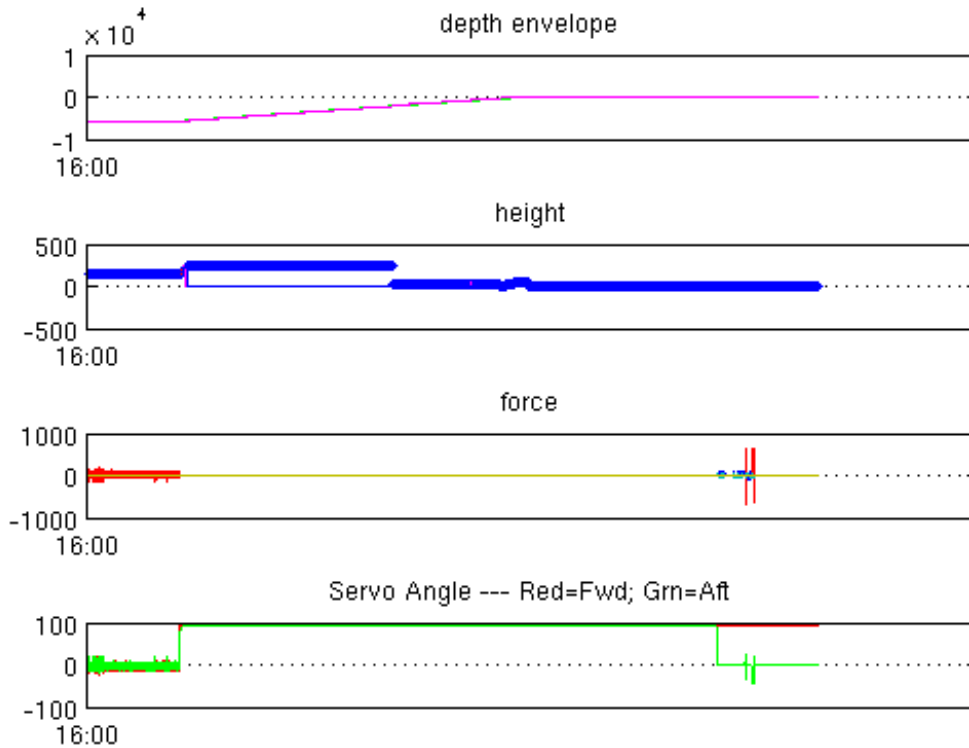
Figure 8: Servo positions during dive 128

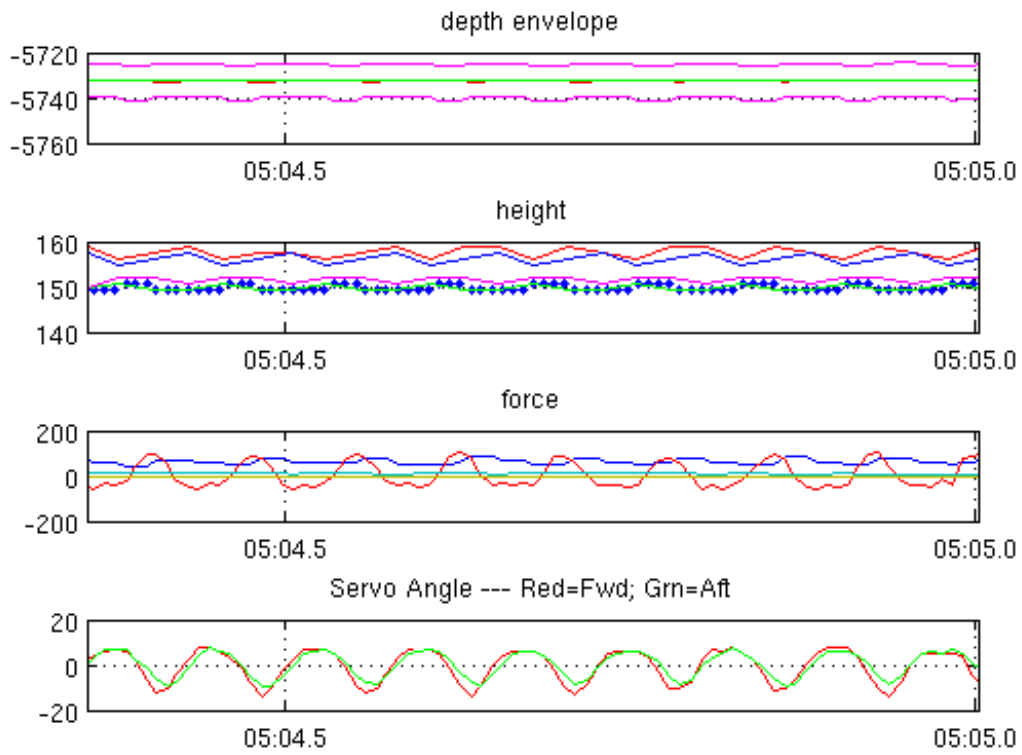
While it did not cause the loss of any dives, a limit cycling behavior in the servos not seen during *Sentry* dives prior to this cruise was present on dives 127, 128, and 129. After locking the aft servo the

Figure 9: Servo limit cycling on dive 128
??

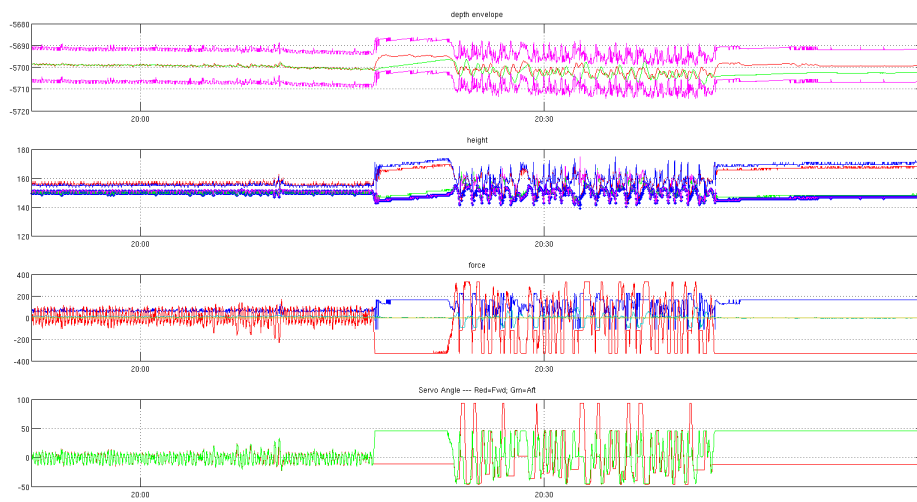
Sentry129 proceeded normally for several hours until the forward servo failed causing the vehicle to crash into the bottom. Full details of this event are given in the Sentry129 dive summary but shown below is the servo position both at the time of the crash and subsequently on ascent. Note that during the crash, the forward servo failed to correctly actuate and the vehicle drove itself into the seafloor. On the ascent, the

Figure 10: Sentry servo positions during the crash on dive 129

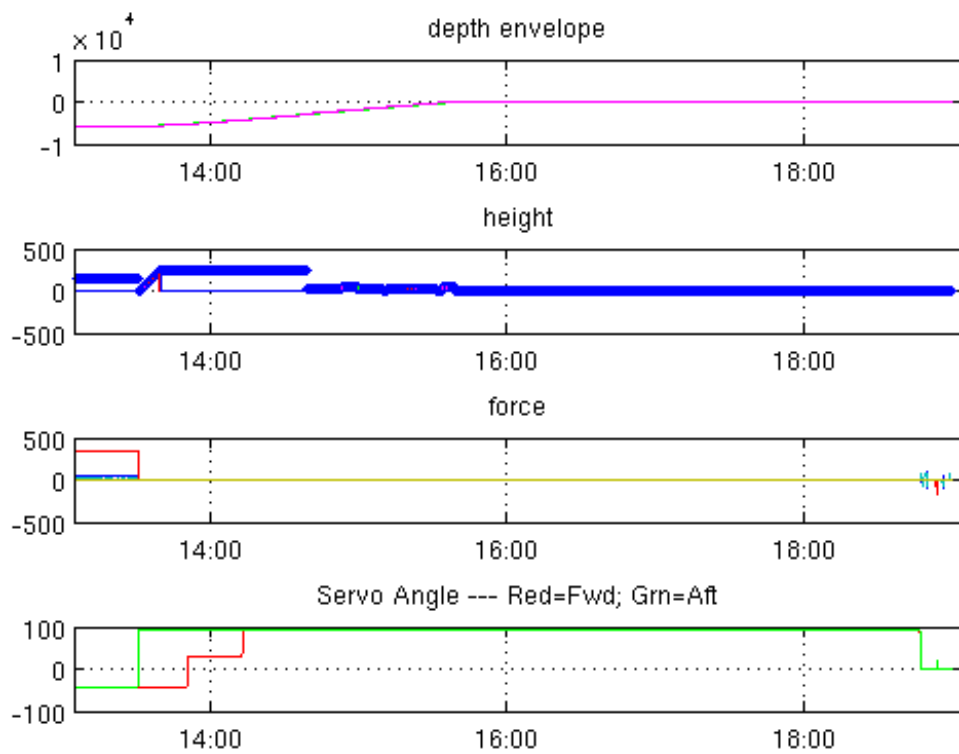
servo was commanded to vertical at the same time as the aft servo, but moved in two stages to vertical over a period of approximately 10 minutes.

Figure 11: Sentry servo positions during ascent on dive 129

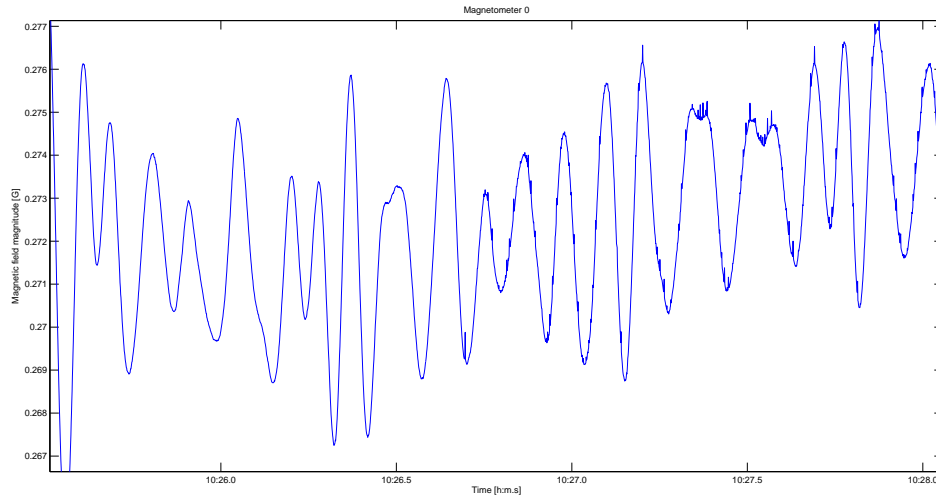
This procedure showed that the source of the magnetic spikes is the DVL while in pinging mode. Given the position within the vehicle of magnetometers 0, 1, 2 this could also explain why magnetometer 2, being farther from the DVL, is showing spikes with less amplitude. This could also explain why the amplitude of the spikes increases while in the water, as the DVL is known to increase the output power when submerged.

Figure 12: Total magnetic field for magnetometer 0 during the described test. No noise is present prior to 10:26:30 when the DVL is turned on. After this, spikes are present in the noise. This demonstrates that the DVL is the source of this noise.

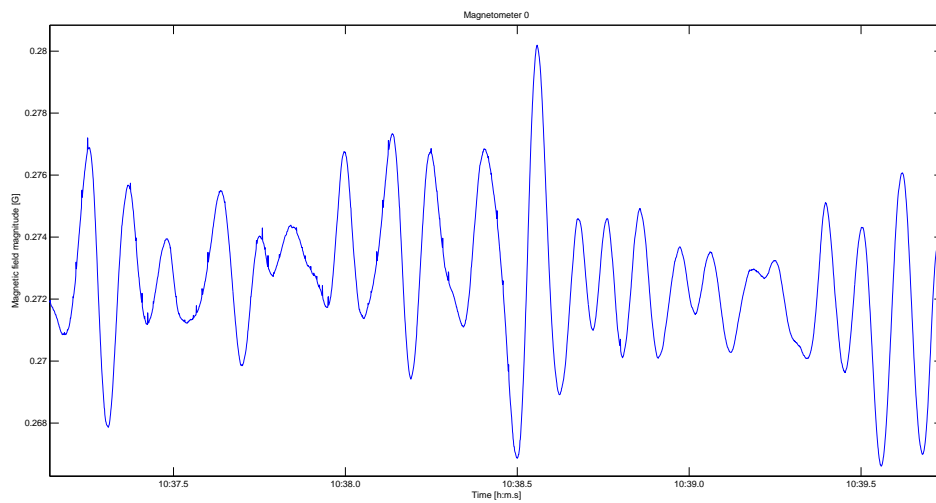
Figure 13: Total magnetic field for magnetometer 0 as the DVL is turned *off*. The noise spikes are present prior to the DVL being turned off at 10:38:30; afterward they are absent.
