SENTRY OPERATIONS REPORT FOR THE
2011 JURASSIC OCEAN CRUST MAGNETIC SURVEY

WHOI ABE/Sentry Operations Group

R/V Thomas G. Thompson — November 5, 2011 to December 17, 2011

Publication Date: January 1, 2012

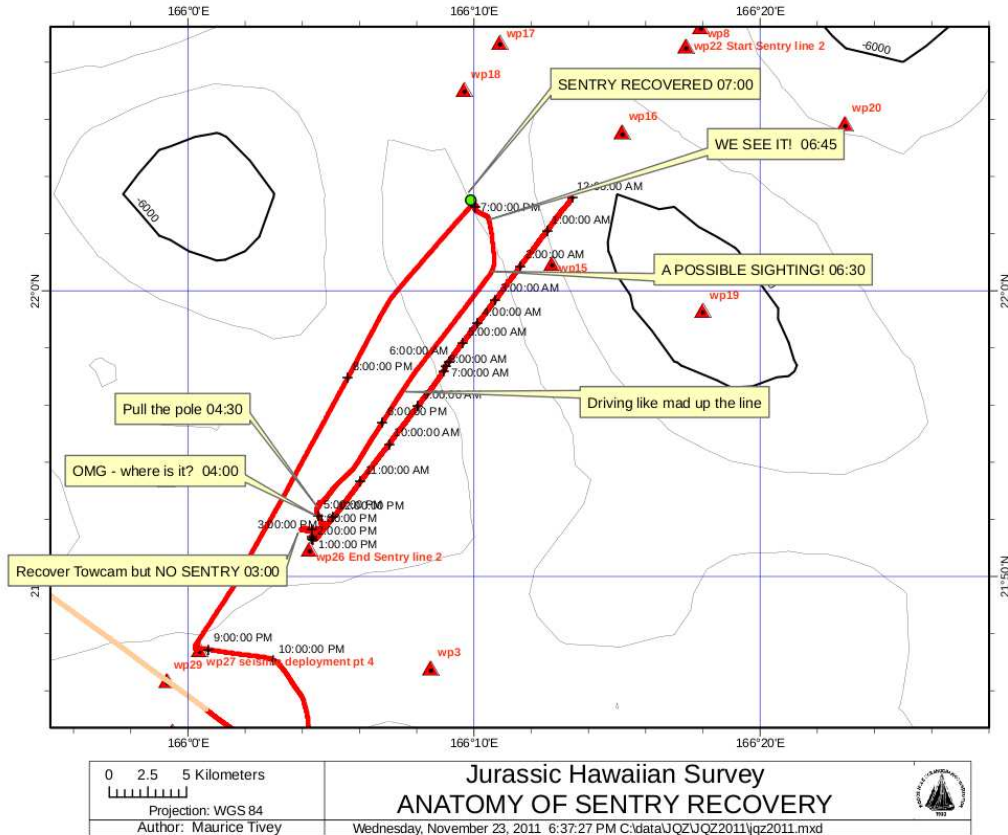
Figure 2: Ship's trajectory of the search pattern during *Sentry* dive 129. Image courtesy of M.A. Tivey (WHOI).

the dive. Inspection of the clutch and external mechanical components show no signs of damage. These facts lead to the conclusion that the failure is inside with servo itself. The failure of 2 servos and a thruster at depth *suggest* a depth related failure mode in the actuators however we *presently cannot definitively conclude this*. The root cause of the failure will likely require additional investigation at WHOI.

1. In hindsight, the decision to continue driving the ship down the line while not having tracking *and* having an acoustic message that the vehicle state was not normal (i.e., depth was close to that of the seafloor, altitude was 1.5m, and speed was slower) was an enormous mistake. We were certain we were ahead of *Sentry* but let a slant range that suggested the *Sentry* was not stopped skew our thinking. On the spot decisions like this are tough and it would behoove us to think about these scenarios in advance.
2. The forward servo failure represented the third actuator failure in as many dives. Testing on deck showed that we could communicate with it and it ??????. Analysis of the data during the dive showed that it the forward servo was being properly commanded and that it was communicating throughout
